# **#08-07-30-021E: Loss of High Speed GMLAN Communications, Intermittent No Crank, IP Gage Fluctuation, Intermittent Door Lock Cycling, Intermittent Chime Operation, Various IP Warning Lamps Illuminated - (Jun 7, 2010)**

**Loss of High Speed GMLAN Communications, Intermittent No Crank, IP Gage Fluctuation, Intermittent Door Lock Cycling, Intermittent Chime Operation, Various IP Warning Lamps Illuminated, Transmission May Not Shift, Communication DTCs U0073, U0100, U0101, U0102, U0109, U0121 or U0140 Set (Repair Backed Out Terminal in Transmission Harness Connector, Repair Open or Shorted GM High Speed LAN Circuits, Open or Shorted Data Link Resistor, Correct Corrosion or Poor Connections in Various Control Module Connectors)**

**2007-2010 Cadillac Escalade Models, XLR  
2009-2010 Cadillac Escalade Hybrid  
2007-2010 Chevrolet Avalanche, Corvette, Silverado, Suburban, Tahoe  
2008-2010 Chevrolet Silverado Hybrid, Tahoe Hybrid  
2007-2010 GMC Sierra, Yukon Models  
2008-2010 GMC Sierra Hybrid, Yukon Hybrid  
2008-2009 HUMMER H2  
Equipped With 6 Speed 6L80 (RPO MYC) or 6L90 (RPO MYD) or Hybrid Two Mode 2ML70 Automatic Transmission  
Please Refer to GMVIS**

**This bulletin is bein

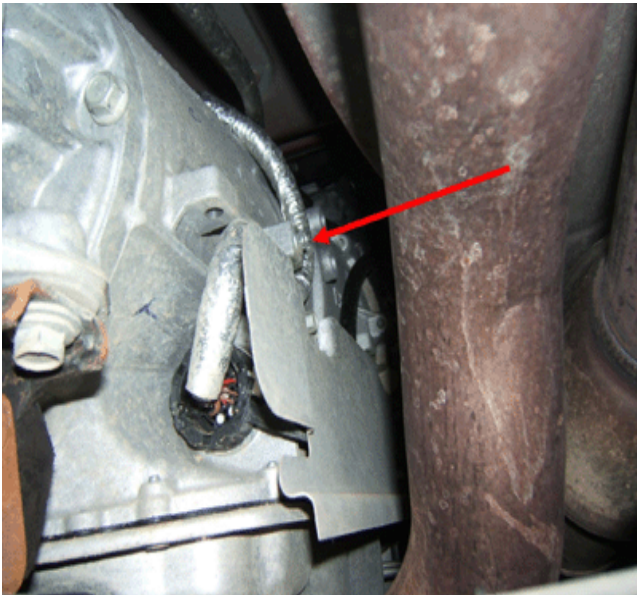
5. Inspect for a pinched/cut wiring harness where it is attached at the transmission by a metal attachment clip as shown. Inspect any of these harness clips that you may observe as needed.

If the wiring is damaged, repair as needed. Refer to Wiring Systems and Power Management > Diagnostic Information and Procedures in SI.

6. Protect the harness by covering the sharp edge with butyl tape or a suitable material. Secure the harness as needed.

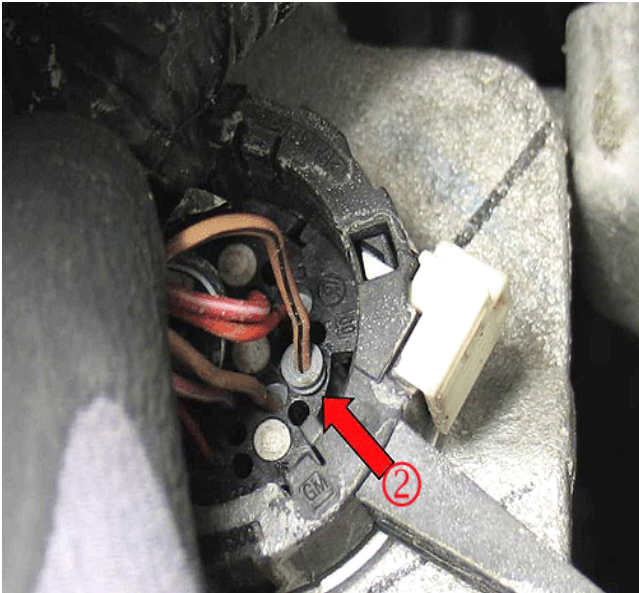
7. **Before** disconnecting the 16-way connector, **inspect** for any backed out terminals (2) as shown. Fully seated terminals (1) are shown for comparison.

- 7.1. If a backed out terminal (2) is found, identify the terminal(s) on the **repair order**.
- 7.2. Look at the connector in order to identify the number of the cavity with the backed out terminal. Refer to Wiring Systems and Power Management > Component Locator > Master Electrical Component List in SI.

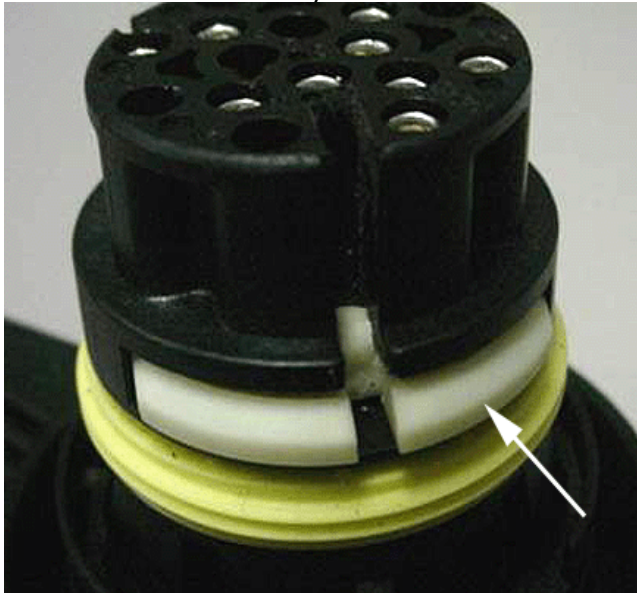
26. Locate the TPA lock in the reassembled transmission connector. Refer to the arrow in the illustration above, which points to a TPA lock. This one is in an unseated position. Using a small flat blade tool, push to seat the TPA until it bottoms out. Verify the TPA is fully seated.
