#PIT4846B: Locations Of High Speed GMLAN Wiring Concerns - keywords cycle gage gauge hard hi lamp LAN lock light MIL off shift short start - (Jan 27, 2010)

Subject: Locations Of High Speed GMLAN Wiring Concerns

Models: 2007-2010 Cadillac Escalade Models

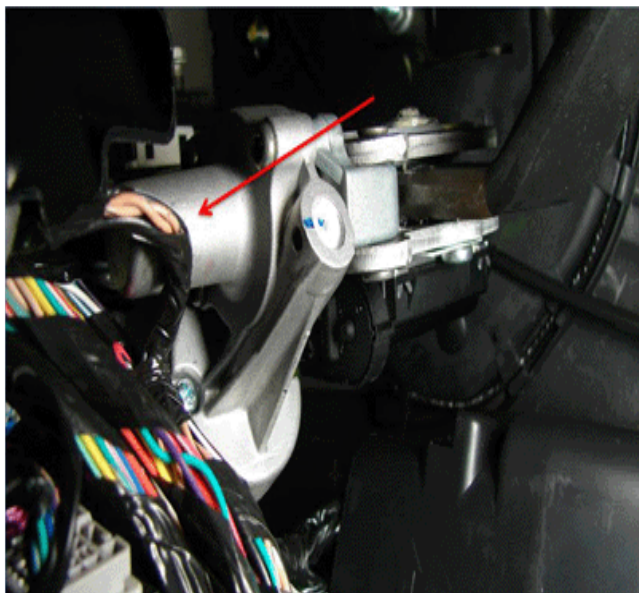
- Adjustable Pedal Motor- As the brake pedal is applied the DLC wiring harness may rub on the adjustable pedal motor and short out, shown below. One hint is the concern will normally occur when the brake pedal is being applied.

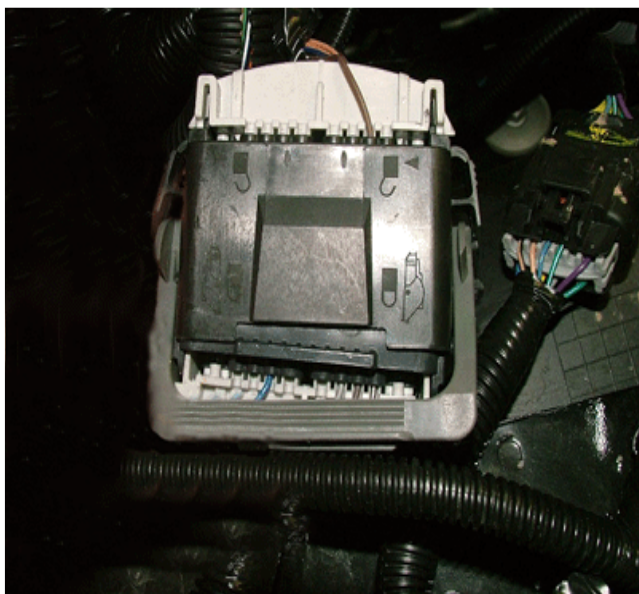
- Inline Connector X109-Inspect for backed out, bent, or poor terminal fit USING THE CORRECT TEST PROBE! Also check for the connector not being fully seated together even though the lever on the connector is locked down, shown below.

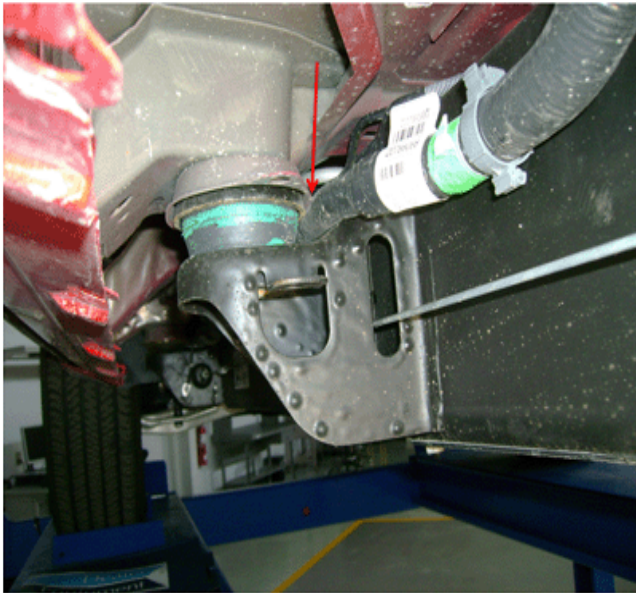
- 6L80/6I90 Auto Trans 16 way Round Pass Through Connector- Review bulletin 08-07-30-021B for more information.
- Chaffed Harness Near Parking Brake Pedal/Sill Plate Area- Refer to bulletin 07-08-49-018 for more information
- Chaffed Harness at the Left IP Junction Block Mounting Bracket- Remove junction block and inspect for any shorted/chaffed wiring.
- Pickup Chassis Harness Chaffing At the Body Mounts Along Left Frame Rail, see below.

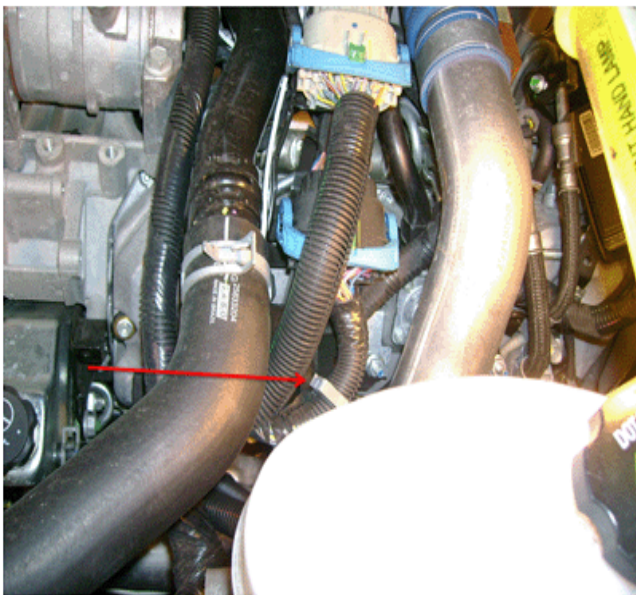
- Trucks with Diesel Engine inspect the engine wire harness for chaffing on the connector/harness mounting bracket at the X108 connector break out, shown below.
