# **#08-07-30-021E: Loss of High Speed GMLAN Communications, Intermittent No Crank, IP Gage Fluctuation, Intermittent Door Lock Cycling, Intermittent Chime Operation, Various IP Warning Lamps Illuminated - (Jun 7, 2010)**

**Loss of High Speed GMLAN Communications, Intermittent No Crank, IP Gage Fluctuation, Intermittent Door Lock Cycling, Intermittent Chime Operation, Various IP Warning Lamps Illuminated, Transmission May Not Shift, Communication DTCs U0073, U0100, U0101, U0102, U0109, U0121 or U0140 Set (Repair Backed Out Terminal in Transmission Harness Connector, Repair Open or Shorted GM High Speed LAN Circuits, Open or Shorted Data Link Resistor, Correct Corrosion or Poor Connections in Various Control Module Connectors)**

**2007-2010 Cadillac Escalade Models, XLR  
2009-2010 Cadillac Escalade Hybrid  
2007-2010 Chevrolet Avalanche, Corvette, Silverado, Suburban, Tahoe  
2008-2010 Chevrolet Silverado Hybrid, Tahoe Hybrid  
2007-2010 GMC Sierra, Yukon Models  
2008-2010 GMC Sierra Hybrid, Yukon Hybrid  
2008-2009 HUMMER H2  
Equipped With 6 Speed 6L80 (RPO MYC) or 6L90 (RPO MYD) or Hybrid Two Mode 2ML70 Automatic Transmission  
Please Refer to GMVIS**

**This bulletin is bein

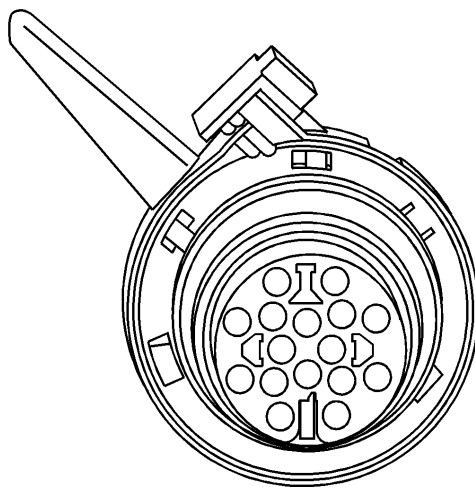
10. Use the following procedure to disconnect the 16-way electrical connector:

- 8.1. For 2ML70 Only: Disconnect the 24-way electrical connector.
- 8.2. Release and hold the slide lock on the wiring harness connector.
- 8.3. Rotate the connector lever and remove the connector from the component.

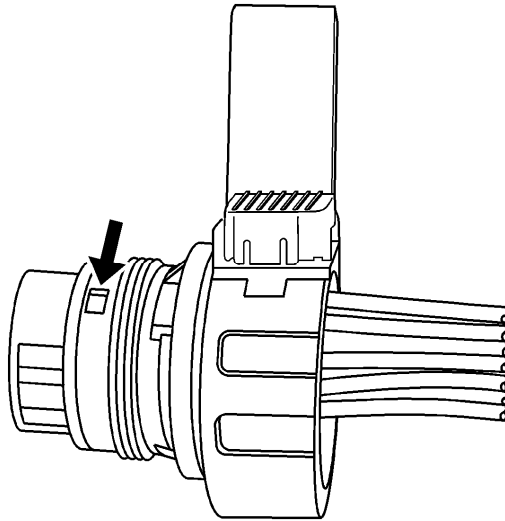
9.1. Locate the terminal position assurance (TPA) as shown.

**Note:** The TPA cannot be removed from the connector while there are terminals present in the connector body.

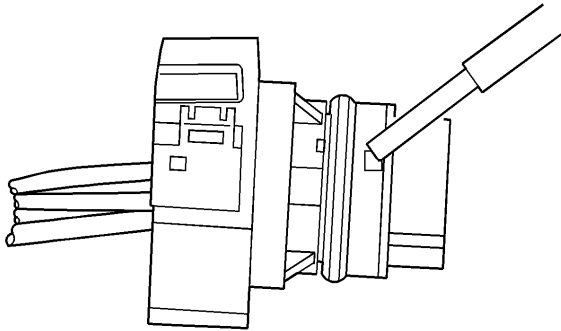
9.2. Use a small flat blade tool to push the TPA until it bottoms out.

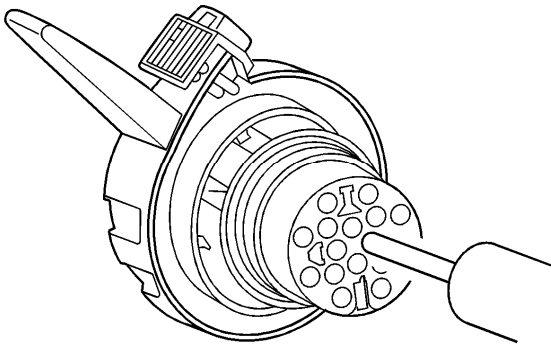
9.3. See the release tool cross reference in the Reference Guide of the J-38125 to ensure that the correct release tool is used. Use the J-38125-28 tool to release the terminals by inserting the tool into the terminal cavity as shown.

9.4. While holding the removal tool in place, **gently** pull the wire out of the back of the connector.

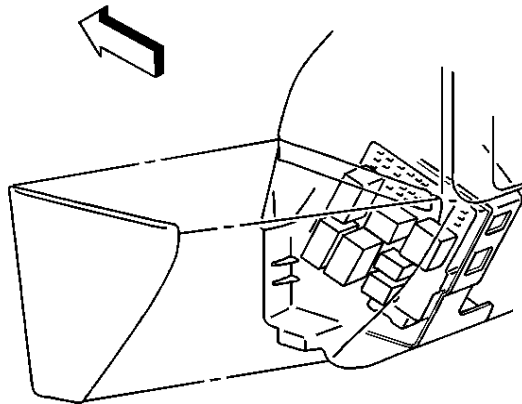
3. Remove the left side fuse block as shown.
